**Flood Control Project Maintenance
Levee Inspections**

Maintenance Issue Types Only, Levee Inspection Report By Mile - Fall 2016

Reclamation District No. 2075 McMullin

Waterway	Bank	Unit Miles	Inspection Start/End	Inspector
Unit No. 01 San Joaquin River	Right	7.45	09/19/2016 09/19/2016	Herman Phillips

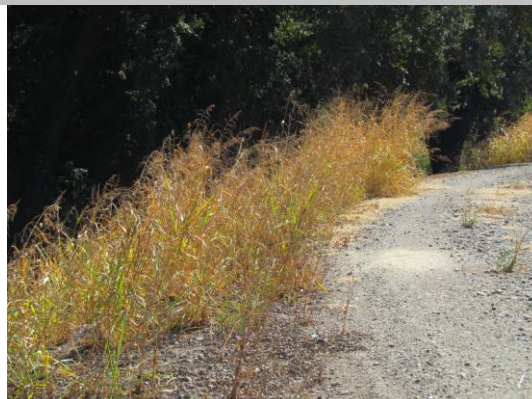
Photo 1 of 1 : FA_2016_RD2075_315_15_20160920_00026.jpg

LM Start	1.01	Rating **	U	Issue No.	15
LM End	1.36	Issue Type +	Ma	Location *	LS
Category	Earthen Levee			GPS Latitude/Longitude	
				Start	End
Item	Vegetation			37.739792 °	37.735405 °
				-121.281220 °	-121.283015 °
DWR ID	DWR_RD2075_01_f_2016_15				
Comment Code					
V2 : Remove the wild growth other than native grasses from the levee slopes.					
Inspector Comment					
Weeds taller than 5-foot on the shoulder and slope. Remove from the levee section.

Looking downstream from the landside levee slope.

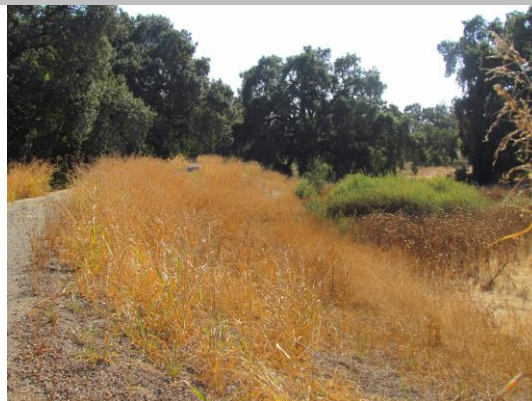
Photo 1 of 1 : FA_2016_RD2075_315_16_20160920_00027.jpg

LM Start	1.01	Rating **	U	Issue No.	16
LM End	1.36	Issue Type +	Ma	Location *	WS
Category	Earthen Levee			GPS Latitude/Longitude	
				Start	End
Item	Vegetation			37.739762 °	37.735405 °
				-121.281227 °	-121.283015 °
DWR ID	DWR_RD2075_01_f_2016_16				
Comment Code					
V2 : Remove the wild growth other than native grasses from the levee slopes.					
Inspector Comment					
Weeds taller than 5-foot on the slope and shoulder. Remove the vegetation from the levee section.

RD 2075 Waterside levee slope looking downstream from levee mile 1.01.

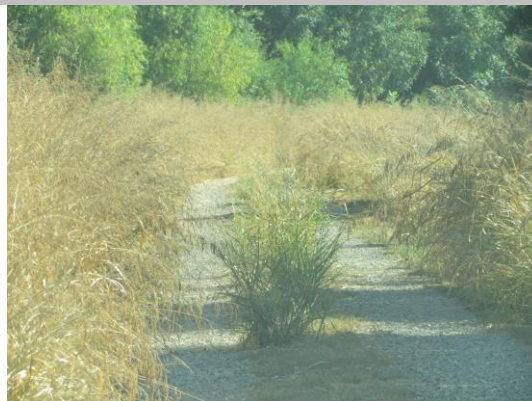
Photo 1 of 1 : FA_2016_RD2075_315_18_20160920_00028.jpg

LM Start	1.13	Rating **	U	Issue No.	18
LM End	1.36	Issue Type +	Ma	Location *	CR
Category	Earthen Levee			GPS Latitude/Longitude	
				Start	End
Item	Vegetation			37.738038 °	37.735405 °
				-121.281702 °	-121.283015 °
DWR ID	DWR_RD2075_01_f_2016_18				
Comment Code					
V9 : Keep the crown roadway free of vegetation.					
Inspector Comment					
Remove the unwanted weeds from the crown. The roadway should be free of vegetation.

Looking downstream from levee mile 1.13- 1.36.

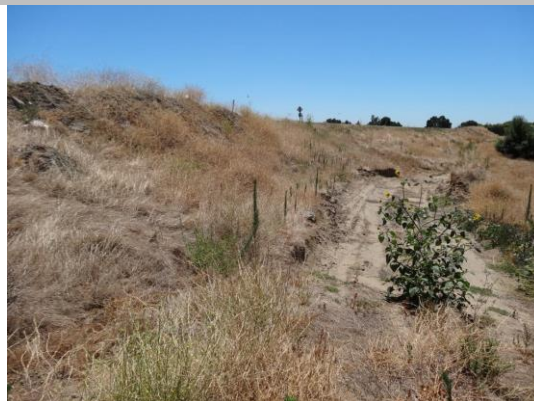
Photo 1 of 3 : SJR2016_RD2075U01RM64.34_1.jpg

07/12/2016: No significant change observed.
 08/28/2015: No significant change observed. Loose material is visible at the upper levee slope. The loose soil may have been caused by runoff.
 08/18/2014: No significant change observed.
 09/10/2013: No significant change observed.
 09/13/2012: No significant change observed.
 08/18/2011: No significant change observed. Some new material added to the water side levee slope, but the added material is loose and seems not helping the levee protection.
 10/05/2010: No significant change observed. Levee slope has minimal vegetation and lacks rip rap protection. Sandy material found on the lower and middle slope is an undesirable material to have on a levee.
 08/05/2010: Recommended for annual assessment and monitoring during flood events, per CLRO.
 08/20/2009: No major change since last visit; site is located in an oxbow; slope surface consists of very sandy material; there is a tree on site leaning and with exposed tree roots; site is recommended as a local maintenance issue, per CLRO CES Evaluation 2008 Report; Eddy Cordoza from the district is aware of the site and is looking for recommendation; site is previously rated "U".

08/17/2007: Site is close to an irrigation pump inlet. [2016 Site ID:RD2075U01RM64.34]

Upstream view of the erosion site.

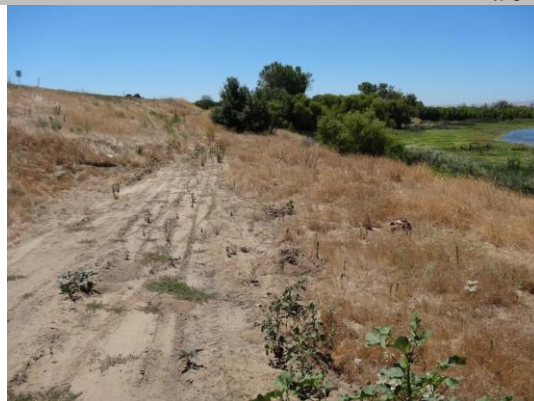
Photo 2 of 3 : SJR2016_RD2075U01RM64.34_3.jpg

Looking upstream at the site.

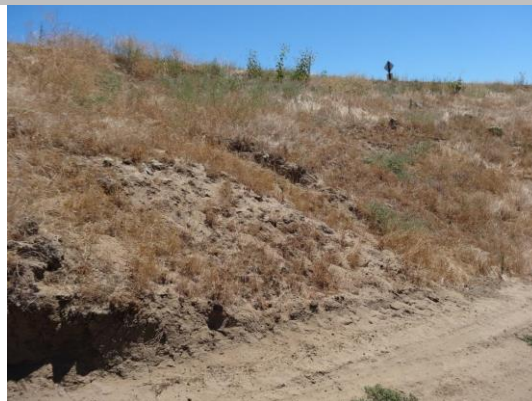
Photo 3 of 3 : SJR2016_RD2075U01RM64.34_4.jpg

07/12/2016: No significant change observed.
 08/28/2015: No significant change observed. Loose material is visible at the upper levee slope. The loose soil may have been caused by runoff.
 08/18/2014: No significant change observed.
 09/10/2013: No significant change observed.
 09/13/2012: No significant change observed.
 08/18/2011: No significant change observed. Some new material added to the water side levee slope, but the added material is loose and seems not helping the levee protection.
 10/05/2010: No significant change observed. Levee slope has minimal vegetation and lacks rip rap protection. Sandy material found on the lower and middle slope is an undesirable material to have on a levee.
 08/05/2010: Recommended for annual assessment and monitoring during flood events, per CLRO.
 08/20/2009: No major change since last visit; site is located in an oxbow; slope surface consists of very sandy material; there is a tree on site leaning and with exposed tree roots; site is recommended as a local maintenance issue, per CLRO CES Evaluation 2008 Report; Eddy Cordoza from the district is aware of the site and is looking for recommendation; site is previously rated "U".

08/17/2007: Site is close to an irrigation pump inlet. [2016 Site ID:RD2075U01RM64.34]

Direct view of the levee slope. Note the loose soil possibly caused by runoff.
